**Penrith Park HOA  
Bennett, CO**

Report #: 45456-0  
Beginning: January 1, 2023  
Expires: December 31, 2023

**RESERVE STUDY  
"Full"**

September 14, 2022

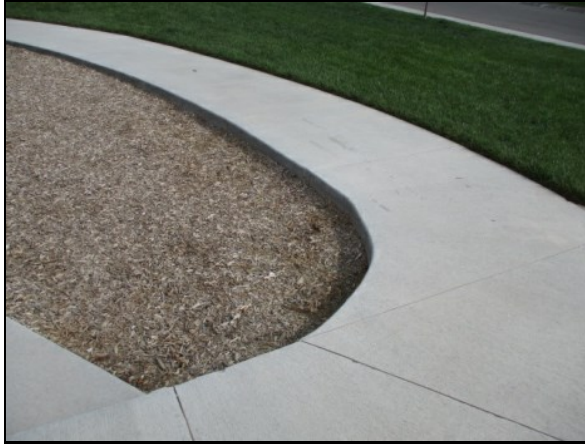
**Comp #: 21090 Concrete Walkways - Repair - 5%**

Comments: Concrete sidewalks determined to be in good condition typically exhibit smooth surfaces with positive slopes. Cracking and trip hazards are not present at this stage. Normal signs of wear and age. The Rocky Mountain region is home to expansive soils. One of the causes of concrete damage in this type of soil moisture. Expansive soils tend to swell in size when wet and contract as they dry out. As the soil expands and contracts it can create enough force to cause major damage to sidewalks. Repair any trip and fall hazards immediately to ensure safety. As routine maintenance inspect regularly, pressure wash for appearance and repair promptly as needed to prevent water penetrating into the base and causing extensive damage. In our experience larger repair/replacement expenses emerge as the community ages. Although difficult to predict timing, cost and scope we suggest a rotating funding allowance to supplement the Operating/maintenance budget for periodic repairs. Adjust as conditions actual expense patterns dictate within future Reserve Study updates.

Useful Life:  
5 years

Remaining Life:  
4 years

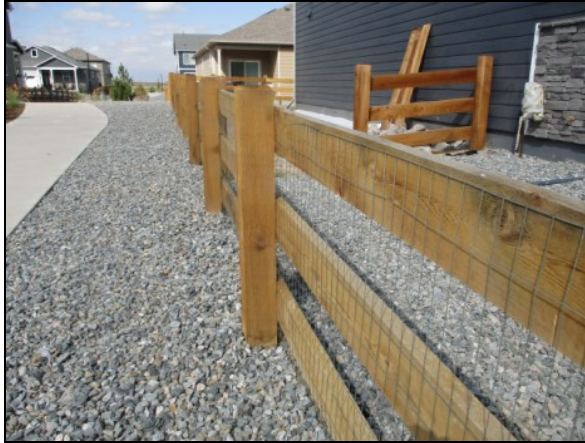
**Comp #: 21320 Site Fencing: Wood - Repair/Paint**

Wood fencing determined to be in good condition typically exhibits a uniform coating or surface finish with only minor deterioration or color fading. Appearance is consistent over most/all areas and has good curb appeal. Regular uniform professional paint or sealer applications are recommended for appearance, protection of wood, and to achieve maximum design life. Repair as needed and clean prior to application. Plan for regular applications as shown below. Timing of repair/paint cycles should be coordinated with eventual fence replacement.

Useful Life:  
5 years

Remaining Life:  
4 years

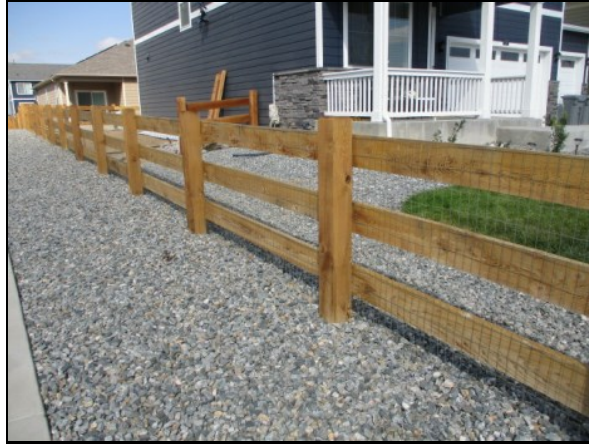
**Comp #: 21340 Site Fencing: Split Rail - Replace**

Wood fencing determined to be in good physical/structural condition is stable and upright with no signs or reports of damage or required repairs. All components and hardware appear to be in serviceable condition with no unusual or advanced signs of wear or age. Fencing is in good aesthetic condition. As routine maintenance inspect regularly for any damage, repair as needed, and avoid contact with ground and surrounding vegetation wherever possible. Regular cycles of uniform professional sealing/painting will help to maintain appearance and maximize life. In our experience wood fencing will eventually break down due to a combination of sun and weather exposure which is sometimes exacerbated by other factors such as irrigation overspray, abuse, and lack of preventive maintenance. Recommendation and costs shown here are based on replacement with similar style and material.

Useful Life:  
25 years

Remaining Life:  
24 years

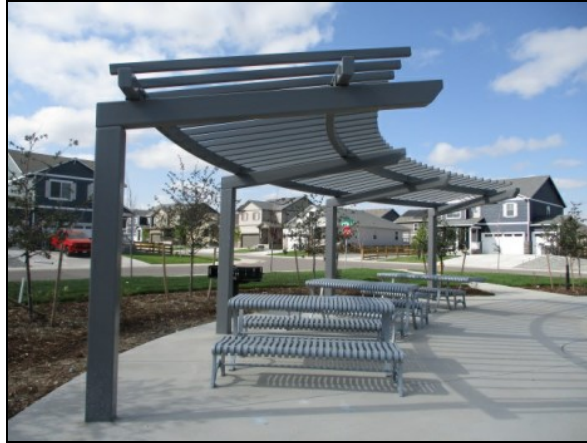
**Comp #: 21430 Pergola – Repair/Replace**

Comments: Pergola measures approximately 45'x10'. Metal pergola structures determined to be in good condition typically exhibit good, consistent finishes or coatings and all frame members and hardware appear to be strong and sturdy. Appearance is good and upholding aesthetic standards of the development. As routine maintenance, inspect regularly and repair individual pieces or sections as needed from general Operating funds. Clean and repair along with other larger projects or as general maintenance to preserve the appearance of the pergola and extend its useful life. If present, vegetation should be well-maintained and not allowed to become overgrown, which can eventually compromise the structure. Assuming ordinary care and maintenance, plan for major repairs or possibly complete replacement (if warranted) at roughly the interval indicated below.

Useful Life:  
40 years

Remaining Life:  
39 years

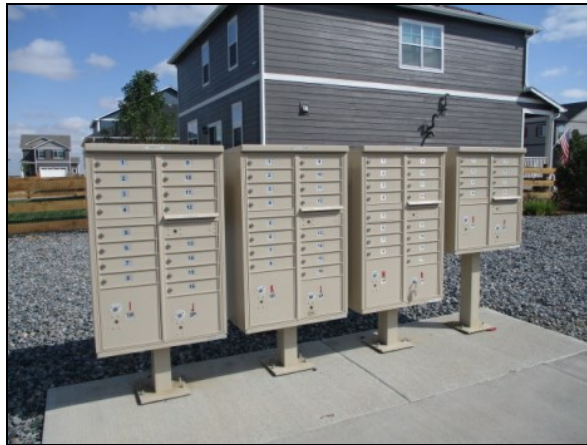
**Comp #: 21600 Mailbox Kiosks - Replace**

Comments: Mailbox kiosks determined to be in good condition typically exhibit a uniform appearance without much surface wear. Hardware appears to be in good condition and boxes/panels appear to close and lock properly. Appearance and style are consistent with the aesthetic standards of the development. Inspect regularly and clean by wiping down exterior surfaces. If necessary, change lock cylinders, lubricate hinges, and repair as an Operating expense. Best to plan for total replacement at roughly the time frame below due to constant exposure, usage and wear over time. Note USPS has a limited budget for replacement and should not be relied upon for purposes of long term planning.

Useful Life:  
30 years

Remaining Life:  
29 years

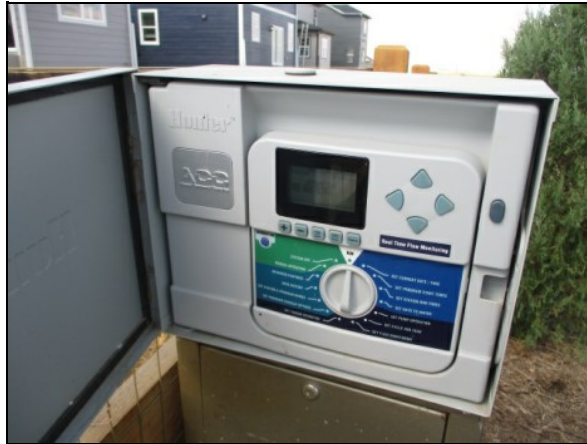
**Comp #: 25570 Irrigation Clocks - Replace**

Comments: Minimal or no subjective/aesthetic value for this component. Useful life is based primarily on normal expectations for service/performance life in this location. Unless otherwise noted remaining useful life expectancy is based primarily on original installation or last replacement/purchase date. Irrigation controllers should have a relatively long life expectancy under normal circumstances. Replacement is often required due to lack of available replacement parts, lightning strikes, etc. as opposed to complete failure of existing equipment. Exposure to the elements can affect overall life expectancy and controllers should be located in protected areas or within protective enclosures whenever possible. When evaluating replacement options the client should consider replacement with "smart" models (i.e. respond to projected weather data) to minimize unnecessary water usage. Payback period for efficient controllers that minimize water use is typically very short

Useful Life:  
15 years

Remaining Life:  
14 years

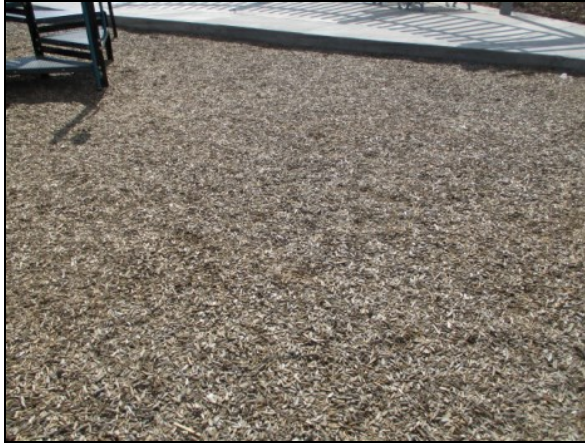
Comments: Coverage was generally sufficient. Playground surfaces should be inspected regularly for hazards, slip and fall risks, etc. Plan to replace at the approximate interval shown here for aesthetic and functional reasons. When evaluating replacement options the client should consult with vendors to ensure adequate protection from falls. Costs shown are based on replacement with same surface type unless otherwise noted.

Useful Life:  
10 yearsRemaining Life:  
9 years

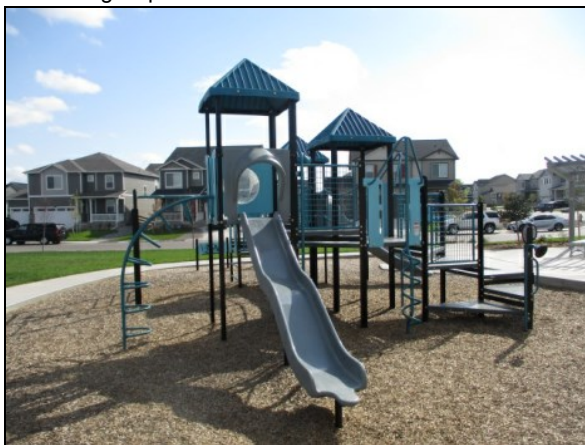
**Comp #: 26050 Playground Equipment - Replace****Quantity: ~ (1) Piece**

Comments: The equipment was observed to be in good condition with no significant issues observed at the time of the inspection. Our inspection is not intended to identify any structural or latent defects, safety hazards, or other liability concerns. Funding recommendation shown here is strictly for budget purposes. As routine maintenance expense inspect for stability, damage and excessive wear and utilize maintenance funds for any repairs needed between replacement cycles. Life expectancy can vary depending on the amount of use/abuse. Unless otherwise noted cost estimates assume replacement would be with comparable size and style of equipment as noted during inspection.

Useful Life:  
20 yearsRemaining Life:  
19 years

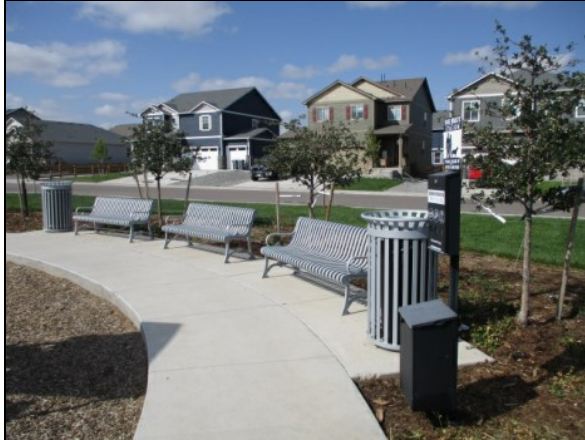
**Comp #: 26060 Picnic Tables/Benches - Replace**

Comments: Includes (3) metal park benches, (3) tables, (6) metal benches near tables, and (2) metal trash cans. Outdoor/site furniture determined to be in good condition typically exhibits little to no signs of wear or age. Style is attractive and appropriate for the local aesthetic standards of the development. Inspect regularly, clean for appearance and repair as needed from general Operating funds. Cost to replace individual pieces may not meet threshold for Reserve funding. We recommend planning for regular intervals of complete replacement at the time frame indicated below to maintain a good consistent appearance in the common areas. Costs shown are based on replacement with comparable types unless otherwise noted.

Useful Life:  
30 years

Remaining Life:  
29 years

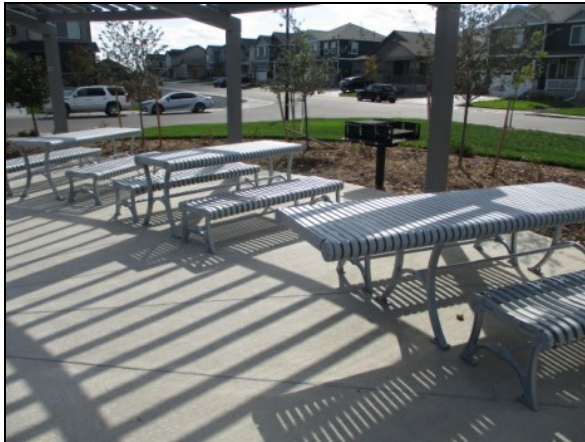
**Comp #: 26070 Grills/BBQs – Replace**

Comments: BBQ was observed to be in good condition. No rust or corrosion noted. Barbecues were not tested during site inspection and are assumed to be functional. Should be cleaned after each use and covered when not in use in order to prolong life expectancy. Cost to replace one grill does not meet Reserve funding threshold and should be handled as an Operating expense.
